# Remediation Strategies and Water Quality of Estuarine Impoundments

Jens Lamping

A thesis submitted in partial fulfilment of the requirements of the Council of the University  
of Durham for the Degree of Doctor of Philosophy (PhD)

### **Remediation Strategies and Water Quality of Estuarine Impoundments**

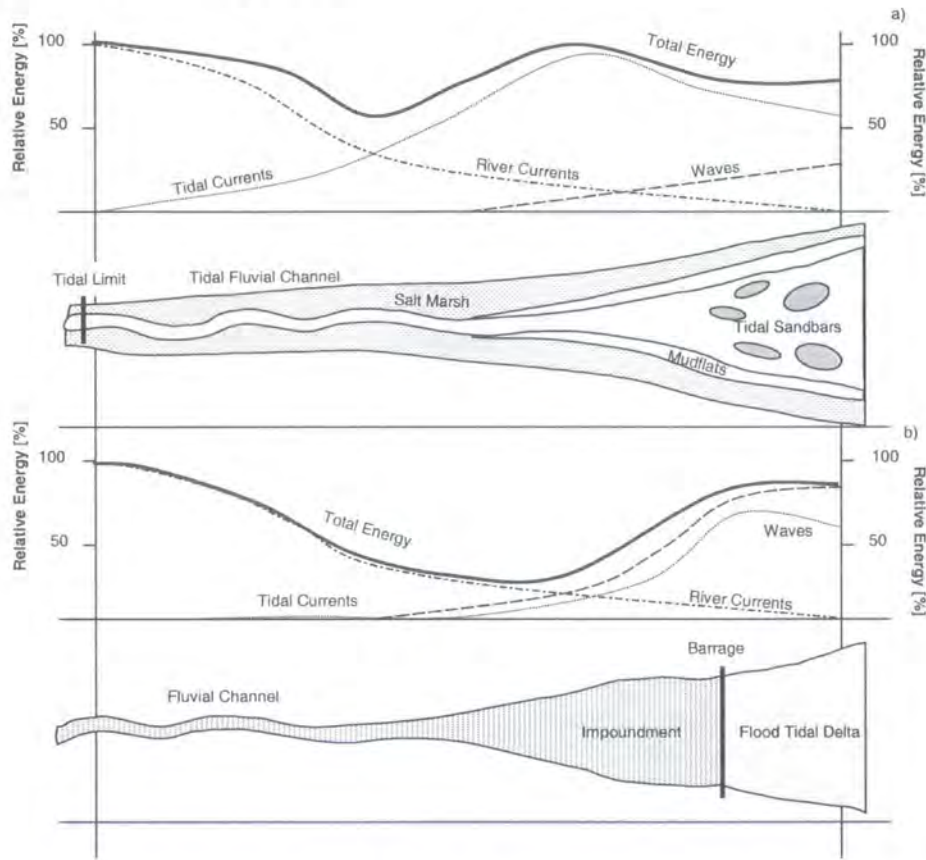
Figure 1-2 Distribution of relative energy pre-and post-impoundment (after Dyer, 1997)

A barraged estuary shows a completely different behaviour as a result of the disturbed hydrodynamic conditions brought by the blocking structure. The marine and fluvial energies entering the estuary are largely reduced and energy reaches minimum levels where former maxima existed (Figure 1-2).

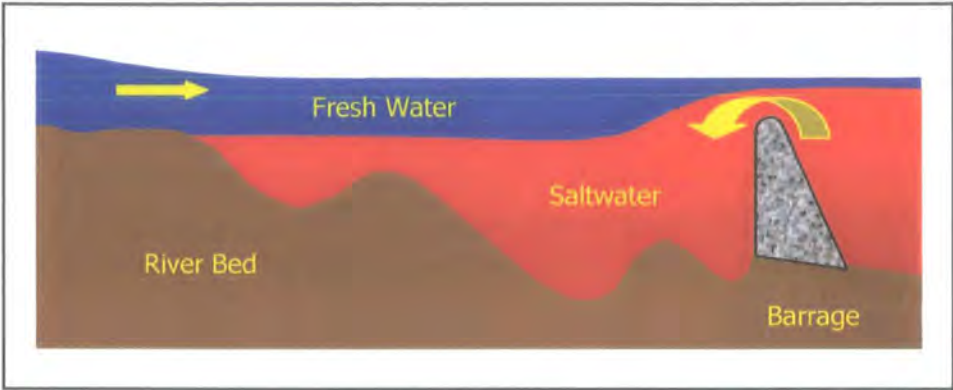
Figure 1-3 Saltwater intrusion into an impoundment during spring tide overtopping (schematic)

This can lead to long periods of stagnant conditions within the impoundment depending on the river discharge and relative height of the barrage crest to the tidal range. In partial exclusion systems, it was observed (Evans and Rogers, 1996) that the overtopping seawater plunges to the ground on entry which forces the lighter freshwater to flow seawards on top (Figure 1-3). Although mixing of the two water bodies initially occurs in the vicinity of the barrage, it is quickly replaced by a density interface, also known as the halocline, which allows the characteristic salt wedge to travel upstream below the fresh water surface layer.

Upstream progression of the salt wedge is dependent on spring tide levels, intensity of the freshwater flows and geometry of the river bed (Dyer, 1997).

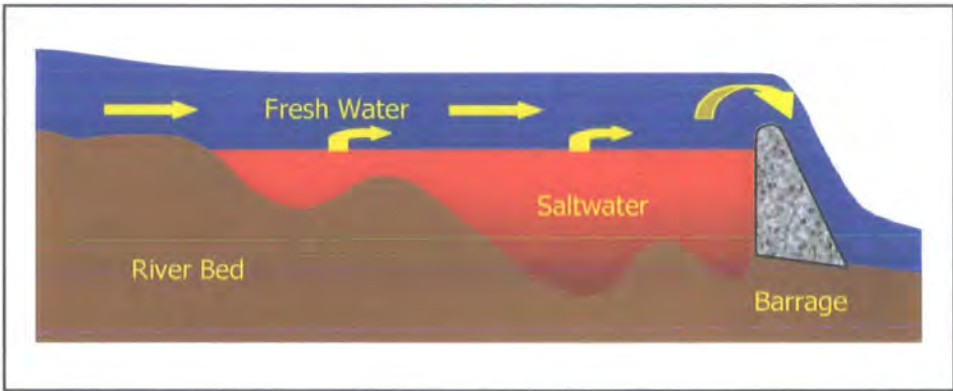
Figure 1-4 Erosion of salt-wedge during non-overtopping conditions (schematic)

After overtopping stops, the freshwater starts to erode the static lower layer at the halocline. The rate of erosion is related to the density difference and the velocity of the layers in the vicinity of the interface (Schijf and Schönfeld, 1953; Harleman, 1961).

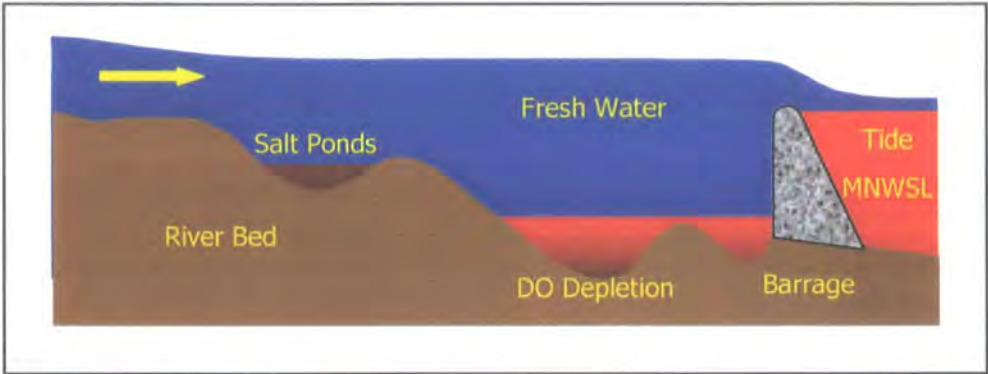
Figure 1-5 Prolonged replenishment of salt wedge during neap tide cycle (schematic)

estuaries, where increased settlement of particulate organic matter is observed. The overlain freshwater layer forms a barrier for atmospheric re-oxygenation while the strong density interface does not allow oxygen exchange within the water column, although the freshwater is saturated at most times. Conditions degrade further when low fluvial flows coincide with long periods of non-overtopping during neap tide cycles (Figure 1-5).

Substantial DO reductions occur in pockets of salt water that are trapped in river bed depressions by the falling halocline, which has detrimental effects to aquatic inhabitants and can also be accompanied by recycling of metals and nutrients from sediments (Evans and Rogers, 1996). In order to prevent the impacts of saline stratification, several remedial measures have been suggested, which include mixing (Figure 1-6), flushing of the system and prevention of saline intrusion by baffles.

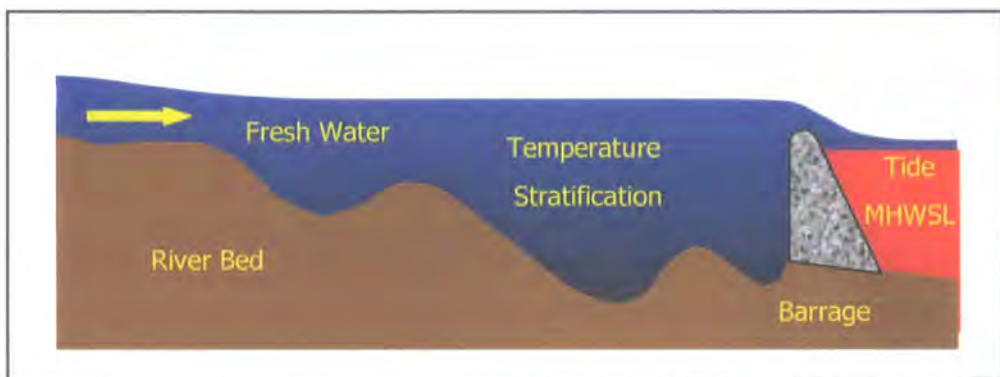
**Figure 1-7 Total exclusion system (schematic)**

Although total exclusion systems are not directly considered as remedial measures, they could be seen as a response to the experience gained from partial exclusion designs. The recently built amenity schemes on the River Tees and at Cardiff Bay follow the concept of completely excluding tidal waters, to prevent the negative impacts of density stratification. However, they could be subject to a weaker form of density stratification as a result of temperature differences, which was observed in river impoundments (Wunderlich, 1971). These freshwater impoundments, or also referred to as reservoirs, have thermal regimes similar to lakes with the addition of substantial inflow and outflows (Wunderlich and Elder, 1967). Sunlight warm up of the epilimnial layer during the spring-summer season can create large variations in temperature within the water column (Figure 1-7), as observed in large freshwater impoundments on the Tennessee River (Churchill and Nicholas, 1967).

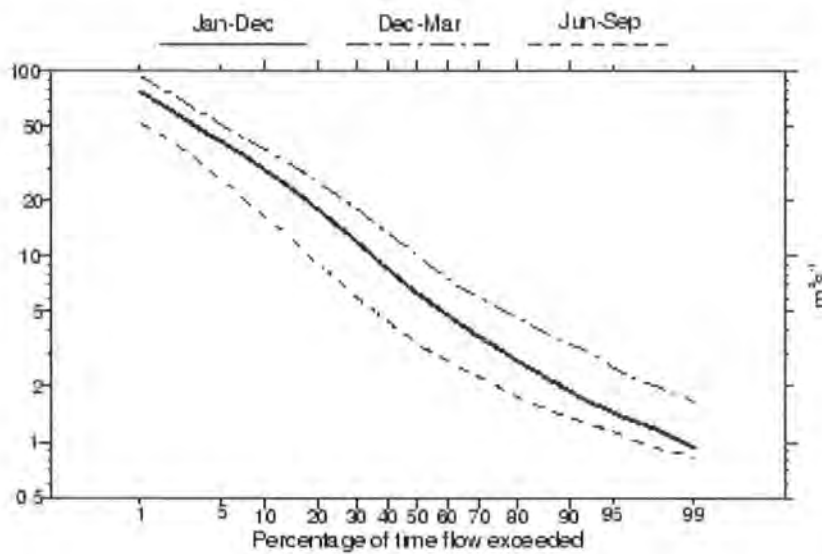
**Figure 2-2 Flow duration curve for gauged daily flows 1957-2003 (National River Flow Archive, 2003)**

The flashy nature of the Tawe results from fluvial flows, which consist primarily of surface runoff and the melting of accumulated snow in the catchment. In addition, the mountainous character of this relatively small catchment leads to heavy annual rainfalls with an uneven distribution, further promoting high and rapid rates of runoff. As a result, the base flow is comparably low with a 75 exceedance flow of  $3 \text{ m}^3/\text{s}$  (Figure 2-2), while the mean daily flow is given as  $12.13 \text{ m}^3/\text{s}$  for a 46-year-period (National River Flow Archive, 2003), raising its sensitivity towards pollutants contributing to the flow.

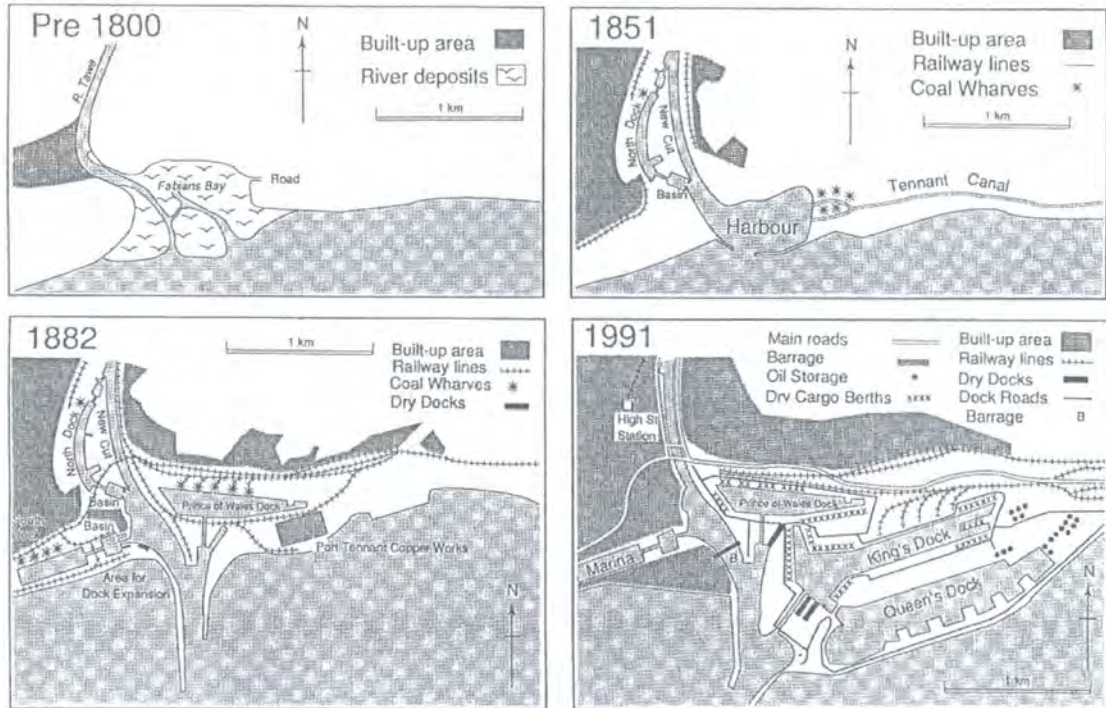
Figure 2-3 Evolution of the Tawe Docks (Dyrynda, 1994)

city of Swansea and discharged into an open bay area called Fabians Bay (Figure 2-3). With the start of the industrial developments, the bay was transformed into a harbour. The original meander was cut across by an artificial straight channel, known as New Cut, to convert the isolated bend into a tidal dock. With the expansion of the lower estuary docks, these North docks were later abandoned and infilled.

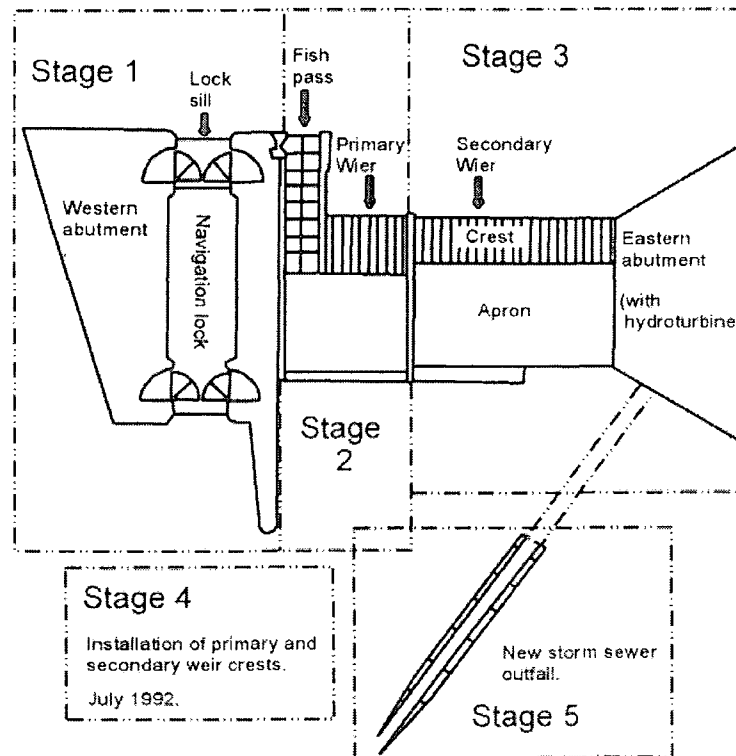
**Figure 2-4 Plan views showing phases of barrage construction (Dyrynda, 1994)**

- Stage 1 (-early 1991) construction of Navigation lock within a temporary doubled walled coffer dam while the flow passes in a restricted channel.
- Stage 2 (-late 1991) construction of primary weir foundation and fishpass within a central enclosure while flow is diverted to navigation lock and temporary eastern channel.
- Stage 3 (-June 1992) construction of secondary weir foundation and eastern abutment within an eastern enclosure while flow passes mainly through navigation lock at high velocities.

- Stage 4 (-July 1992) removal of all coffer-dams and installation of prefabricated weir crest blocks. Closure of the lock to raise impoundment water level to crest height on the 26/07/92.

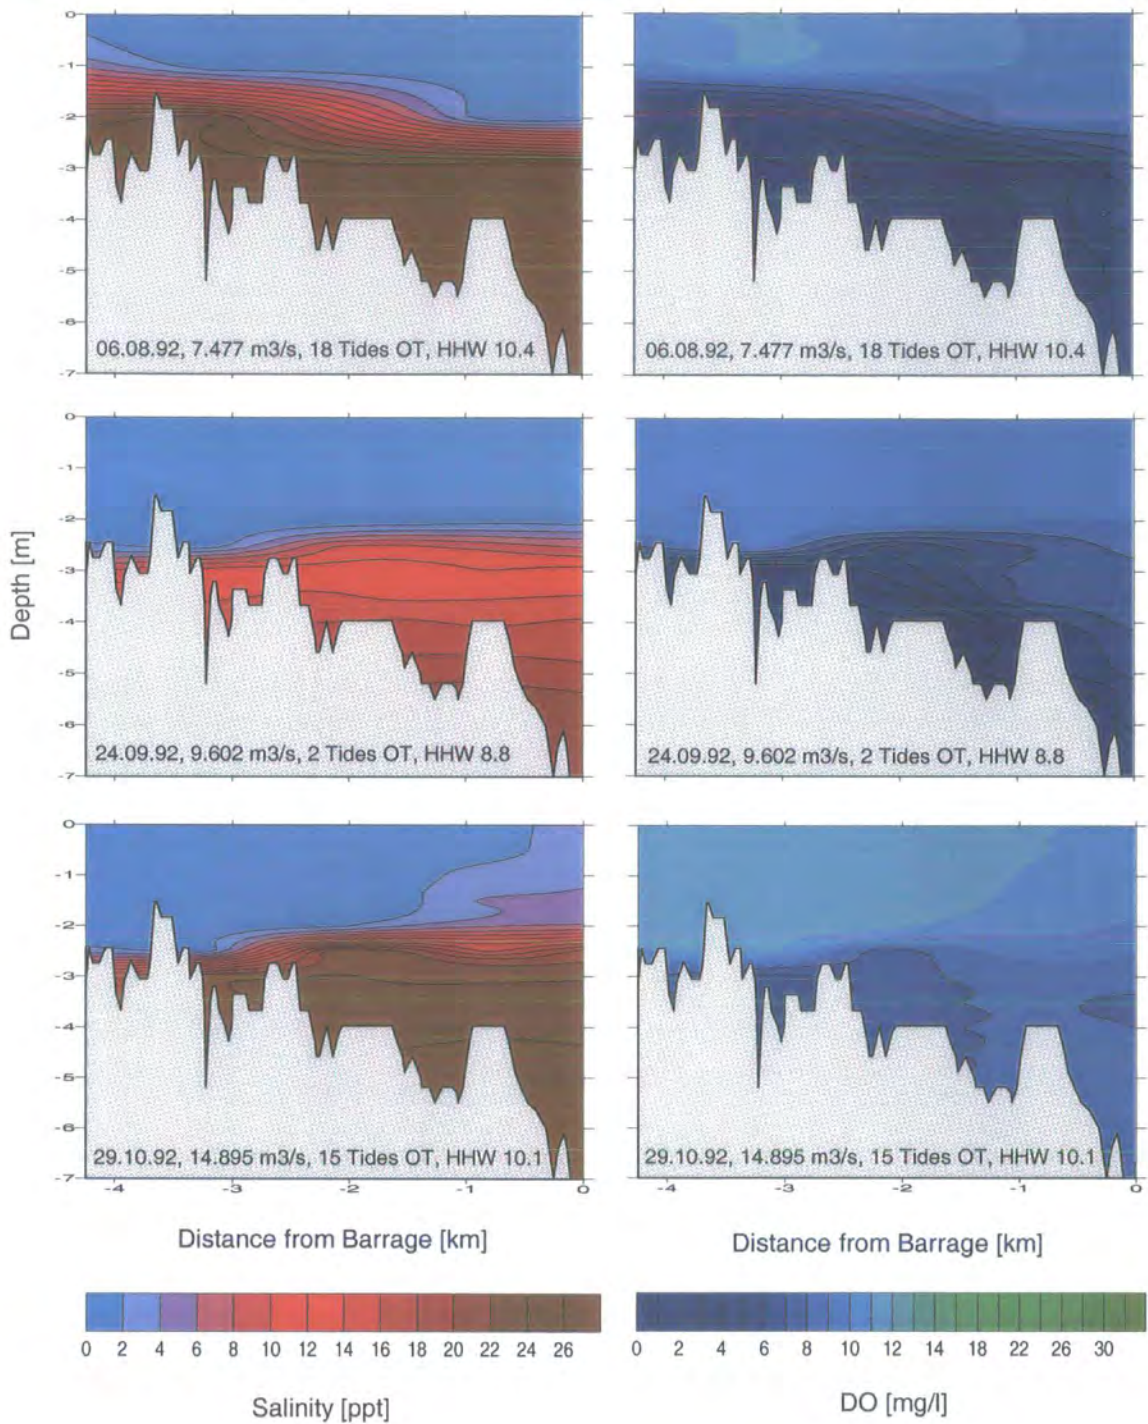
**Figure 2-5 River Tawe Salinity and DO contours after impoundment in 1992**

Profiling surveys carried out by the NRA on the Tawe estuary directly after impoundment already indicated the presence of an extensive static salt wedge fixed behind the barrage, which was covered by an overlain freshwater layer. The monitoring of 06/08/92, 24/09/92 and 01/10/92 (Figure 2-5) showed a highly stratified impoundment, with saline intrusion up to 4.25 km distance from the barrage, accompanied by reduced DO levels in the bottom saline layers.

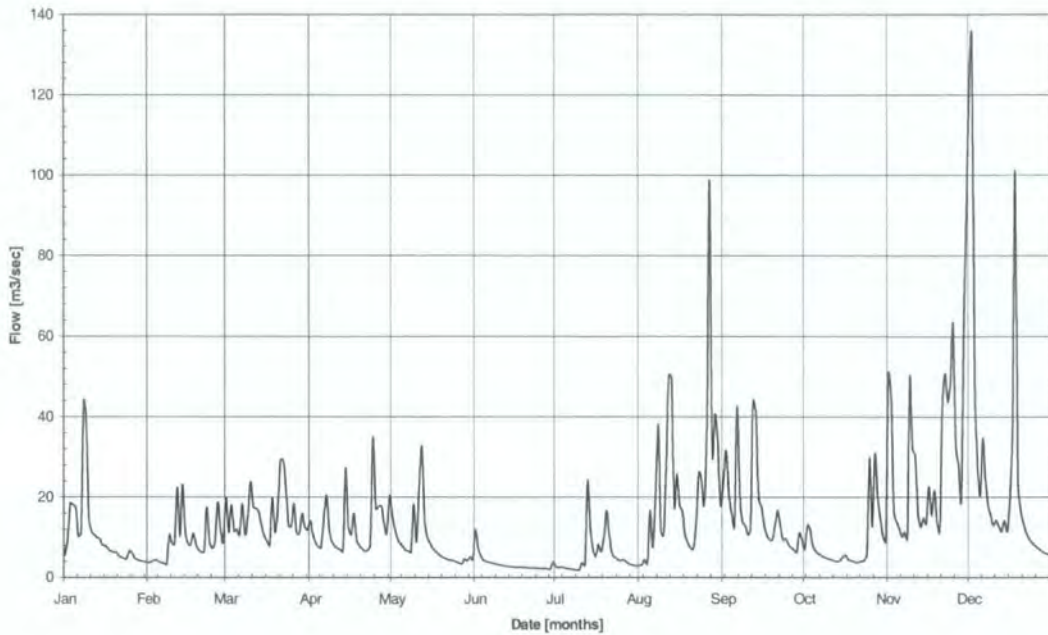
**Figure 2-6 Tawe Flow Data 1992 (EA Wales)**

Fluvial flow spates, however, marked the end of the summer months (Figure 2-6), and alleviated the water quality problems, so that no further action was required to improve water quality in 1992.

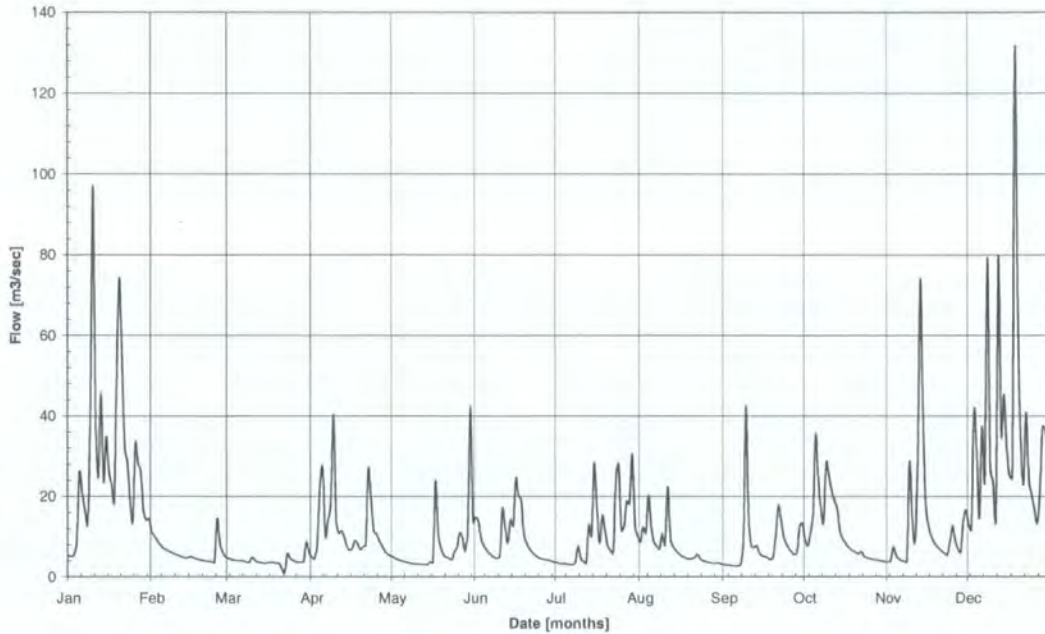
**Figure 2-7 Tawe Flow 1993 (EA Wales)**

By the end of 1993, monitoring still showed a persistent stratification with DO depletion of the lower layers. Nonetheless, the conditions were not as bad as anticipated due to regular occurrence of flow spates (Figure 2-7) and an intensive use of the low level penstocks as part of the lock gate operation.

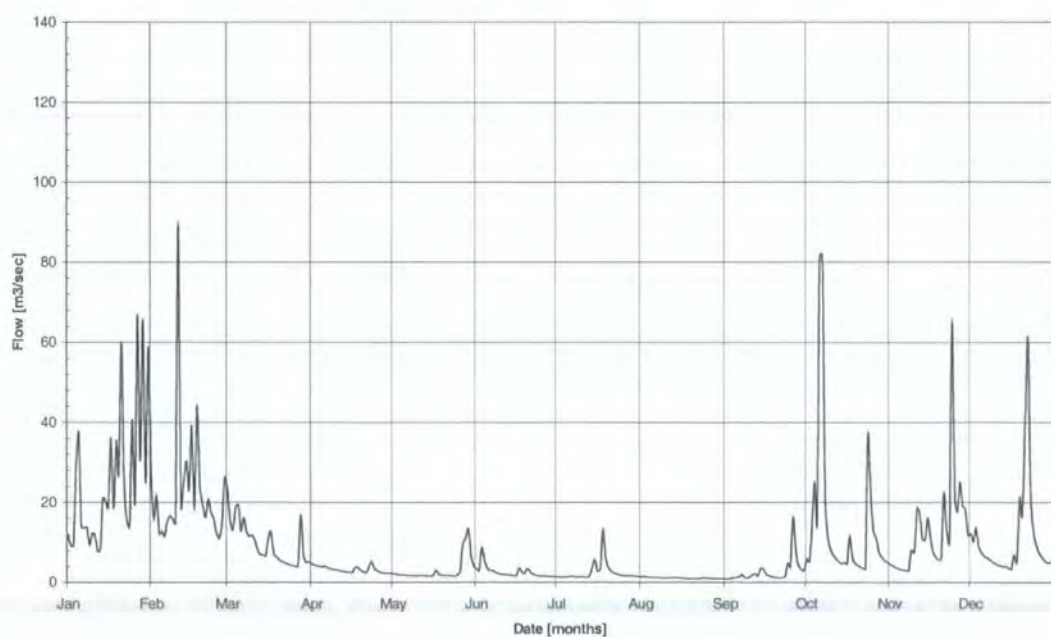
Figure 2-8 Tawe Flow 1995 (EA Wales)

In 1995, penstock sluicing was included in the routine operation of the barrage from March onwards to minimise the risk of water quality deteriorations from the start of the season. The issued sluicing schedules were applied in accordance with the available freshwater flow and minimum water heights required within the impoundment. Due to the encountered limitations of penstock operation as a remedial measure, consideration was given to direct remediation devices that could be applied locally. A joint visit to the Lagan impoundment, Belfast, where mixing devices were installed in 1994, was undertaken. In addition, an emergency response plan was established which specified the actions required for certain water quality conditions, and high-risk periods were identified based on the observations made during the summers of 1993 and 1994 (Rogers and Bryson, 1994; Dyrinda, 1994). These high risk periods were targeted for intensive monitoring and penstock operation, to carry out more sluicing assessments unimpaired by tidal replenishment. The very dry conditions from April to September 1995 (Figure 2-8), resulted in limited sluicing possibilities and competing water demands within the impoundment, since lock operation, fish pass flow and sluicing had to be satisfied. The Hydroelectric Power Plant (ITT EL 7570, max flow:  $1.7 \text{ m}^3/\text{sec}$ , max. output: 96 kW) incorporated in the barrage design and scheduled to go online, was now used to back-pump water into the impoundment for several weeks to maintain water levels.

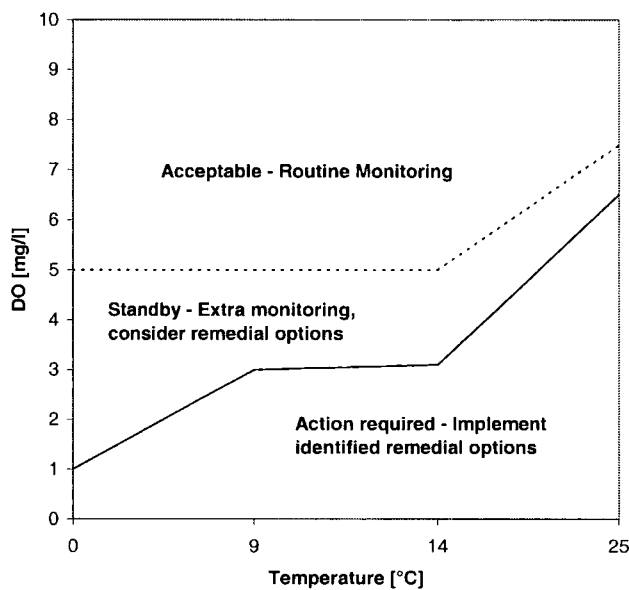
**Figure 2-9 Water Quality Standards to protect salmonids in the Tawe impoundment (Edwards and Bishop, 2000)**

1996 marked a change in the remediation strategy, after a budget had been allocated to SCC for examining further remediation work. Dr. Ken O'Hara from SGS Environment Ltd., Liverpool, presented his approach of a combined aeration/mixing system to break stratification in the impoundment during a Joint Technical Group Meeting in March. The joint water quality monitoring was still ongoing and a sluicing program started in June, targeting neap tide periods until October. The transition of the NRA into the Environmental Agency resulted in a new definition of the liaison between the involved parties, including a proposal for new standards of DO conditions in the impoundment (Figure 2-9). The short-term objective was to apply the standard within the top 1.5 m of the water column and the long-term objective was to achieve conditions above the standard for the whole water column.

Considering the binary nature of the parameter in question, breaching or complying with the DO standard of 5 mg/l (Figure 2-9), logistic regression was the most appropriate technique to calculate a predictive model. This method predicts the outcome of a dichotomous dependent variable from continuous explanatory variables  $X_1, X_2, X_3, \dots, X_p$  (e.g. Depth, Distance from Barrage,  $Q_{\text{freshwater}}$ , etc.) by applying regression coefficients ( $b_1, b_2, b_3, \dots, b_p$ ) with  $b_0$  as an intercept (Howell, 1997). The basic function for the transformation from a probability scale (0,1) to the scale of continuous variables ( $\infty, -\infty$ ) is:

It is indicated (Figure 2-17), that the majority of low DO events (94.3 %) were observed at  $Q_{ave} < 10 \text{ m}^3/\text{s}$ . Monitoring included a range of  $Q_{ave}$  from  $0.968 - 47.956 \text{ m}^3/\text{s}$  and no breach of the standard was recorded for  $Q_{ave} > 22 \text{ m}^3/\text{s}$ . Occasional DO events above  $12 \text{ m}^3/\text{s}$  resulted from deep pockets of trapped brackish water directly behind the barrage (Point 1-Figure 2-17). The two DO events (Point 2-Figure 2-17) at  $Q_{ave} < 12 > 10 \text{ m}^3/\text{s}$  were recorded at the deep upstream site Addis (Figure 2-11) during receding flows with an actual  $Q_s$  of 5 and  $6 \text{ m}^3/\text{s}$ . Considering the short-term water quality objective (Figure 2-9) of ensuring DO conditions above 5 mg/l within the first 1.5 m from the surface, applied

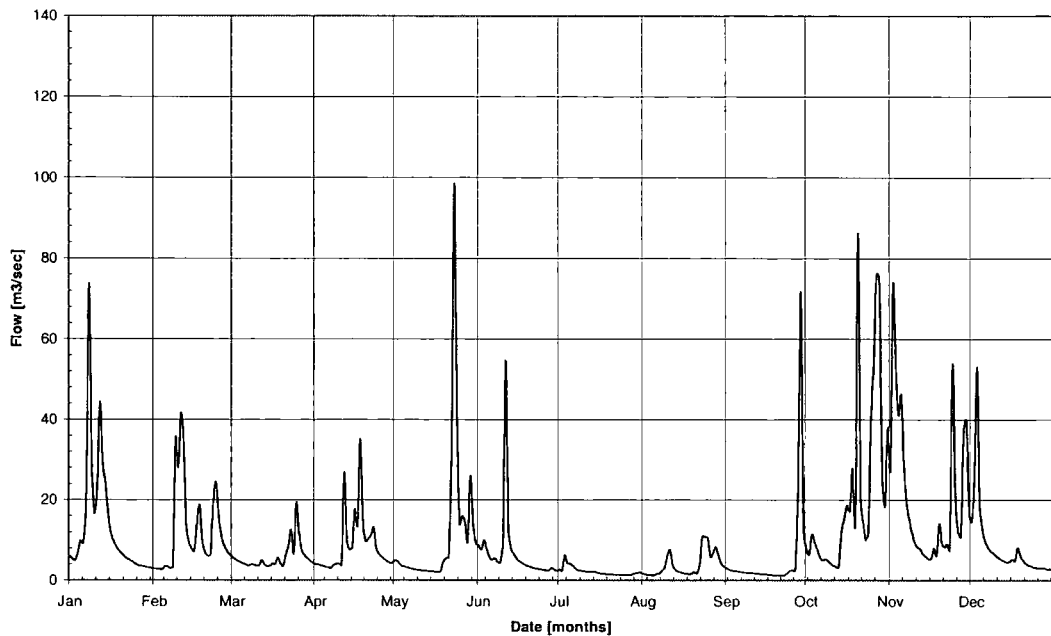
**Figure 2-10 Tawe Flow 1996 (EA Wales)**

in the impoundment. By the end of 1996, the poor water quality conditions were alleviated through extensive sluicing and the regular occurrence of flow spates (Figure 2-10).

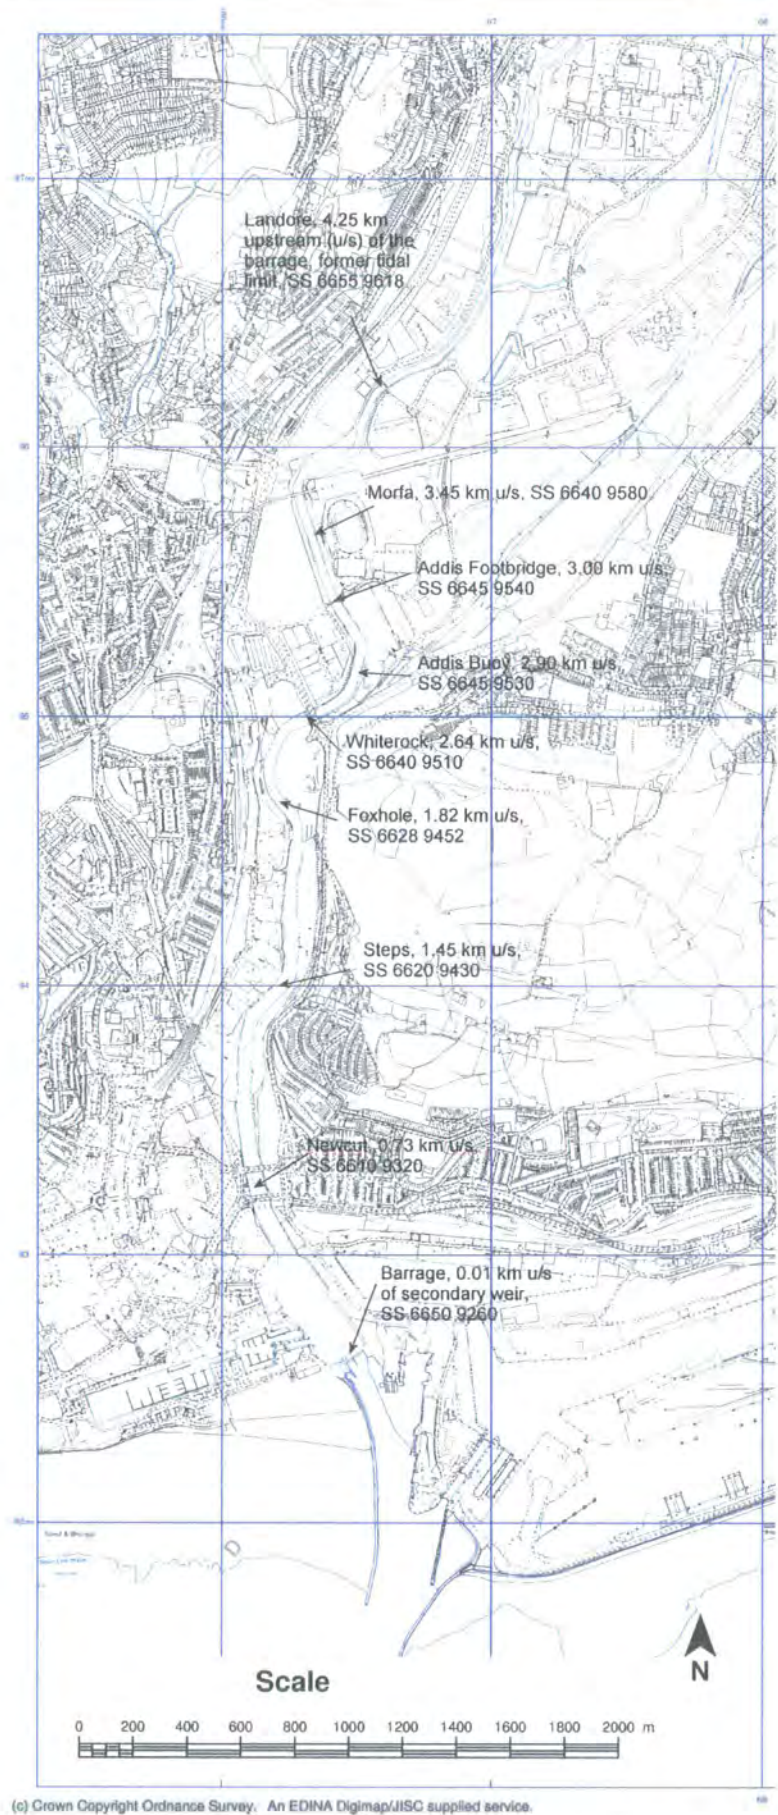
Figure 2-11 EA/SCC monitoring sites on the River Tawe

The following sites within the Tawe impoundment have been consistently sampled during the monitoring program which started in 1993:

- Site Code: Numerical Index (1-9) for the standard monitoring sites on the Tawe (Figure 2-11). Out of the nine sites, seven were included in the ANOVA, since two sites (6-Addis Buoy and 8-Morfa) showed inconsistent monitoring records. The numerical order of the sites increases with distance from the barrage, so that the site code can also be regarded as an unscaled distance code.

Although DO events within the 9  $\text{m}^3/\text{s}$  flow limit are now approaching the 1.5 m margin of the short term objective, the boundary was only breached on one occasion above 5.5  $\text{m}^3/\text{s}$  (Point 5-Figure 2-19). These readings were recorded at the shallow site (Whiterock-Figure 2-11) and appeared to be resulting from upstream pockets of old saltwater being pushed over the elevated Whiterock site during wash out at higher freshwater flows ( $Q_s=7.828 \text{ m}^3/\text{s}$ ).

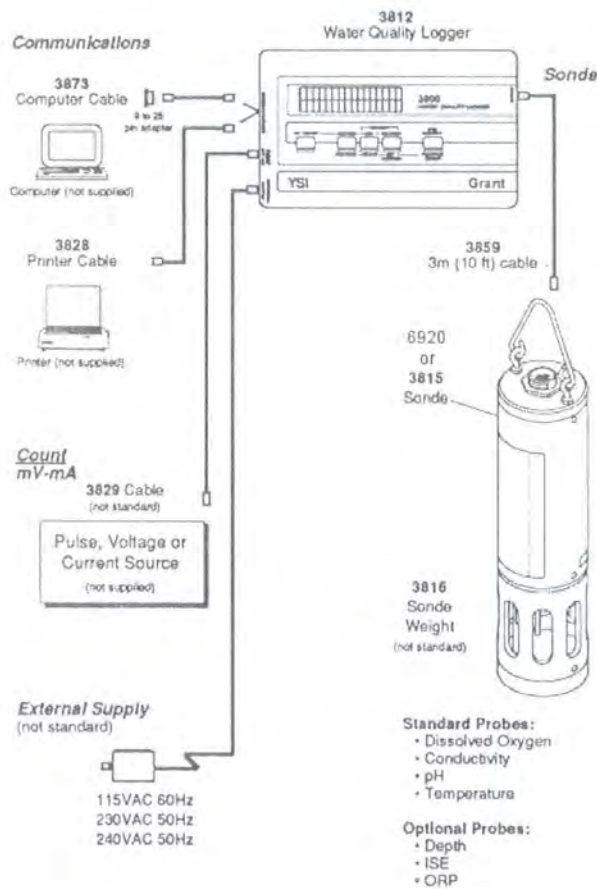
Figure 2-12 Measuring equipment applied

Up until 1997 the SCC/EA data sets were obtained by using a 3800 YSI/Grant Ltd. Data logger system, which consists of a 3815 YSI sonde capable of reading multiple water quality parameters connected to a 3812 Grant Ltd. Data Logger for additional editing (Figure 2-12). During the early years of monitoring (Table 2-2), the data was printed out directly from the logger. In 1998, a 6920 YSI sonde replaced the old model and it was decided to download the readings for further analysis. Both sondes were calibrated regularly with YSI calibration solutions. The DO and pressure sensor were conditioned and calibrated before each monitoring run. Depth of measurement was determined through the pressure sensor included in the sonde setup.

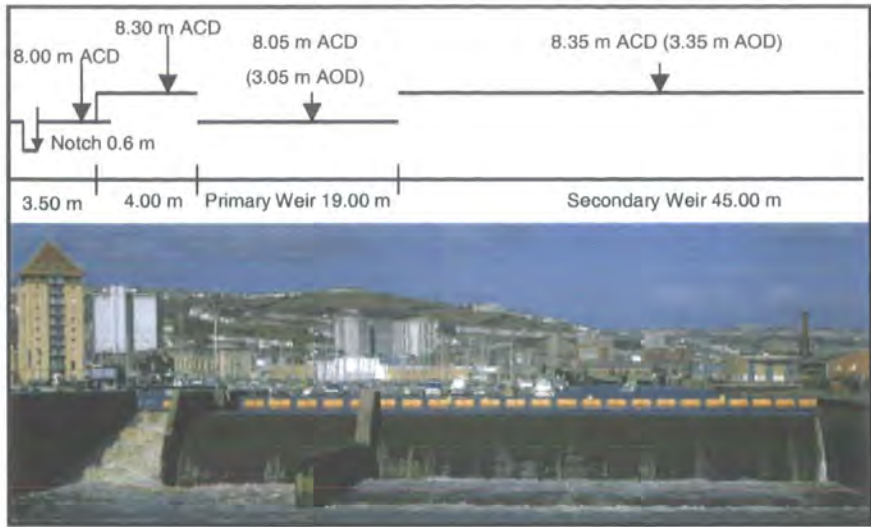
Figure 2-13 Tawe Barrage crest levels (schematic & barrage picture looking upstream)

The overtopping regime was defined as number of tides overtopping (Tides OT), where a negative value describes the number of tides that do not overtop the barrage construction. The tidal regime and the related parameters ( $Q_{\text{ave}}$ ,  $Q_{\text{max}}$ ,  $Q_{\text{tmax}}$ ) were calculated on the initial assumption that seawater intrusion starts at Tide levels  $\geq 8.10$  m ACD (3.10 m AOD). This assumption was made on the basis of levels given for the weir crest construction (Figure 2-13) stated in the construction drawings by W.S. Atkins Ltd. (W.S. Atkins, 1988).

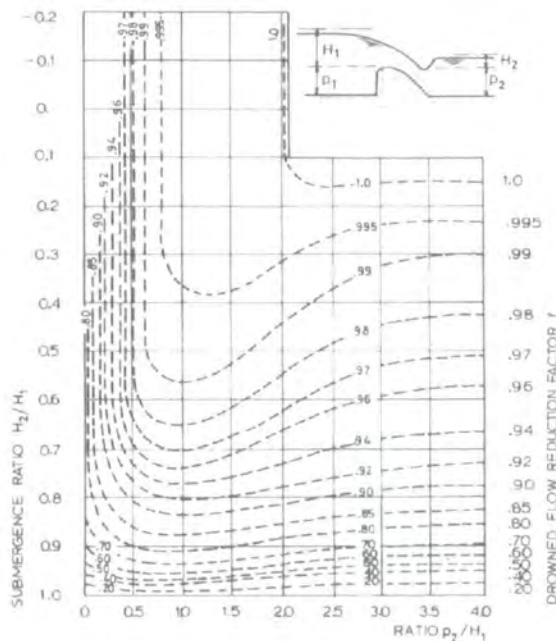
Figure 2-14 Drowned flow reduction factor as a function of submergence ratio  $H_2/H_1$  (Bos, 1990)

Considering a drowned flow reduction factor (Figure 2-14) which has to be applied for the calculation of freshwater discharge and saltwater intrusion over a sharp crest weir, the actual overtopping height can only be an approximation, since it is related to the submergence ratio. Although the head of saltwater can be taken as the observed tide level, no complete recordings existed for the head of freshwater within the impoundment under different flow conditions.

AOD) (Figure 2-15 and Figure 2-16). The variations in the overtopping height are related to the freshwater flow  $Q$ , as suggested in Figure 2-14, and could also be influenced by wind direction and external factors such as lock operation and penstock sluicing times. Therefore, the numerical analysis will only consider an overtopping threshold based on construction levels and predicted tidal heights, while the discussion addresses the possible errors in these factors.

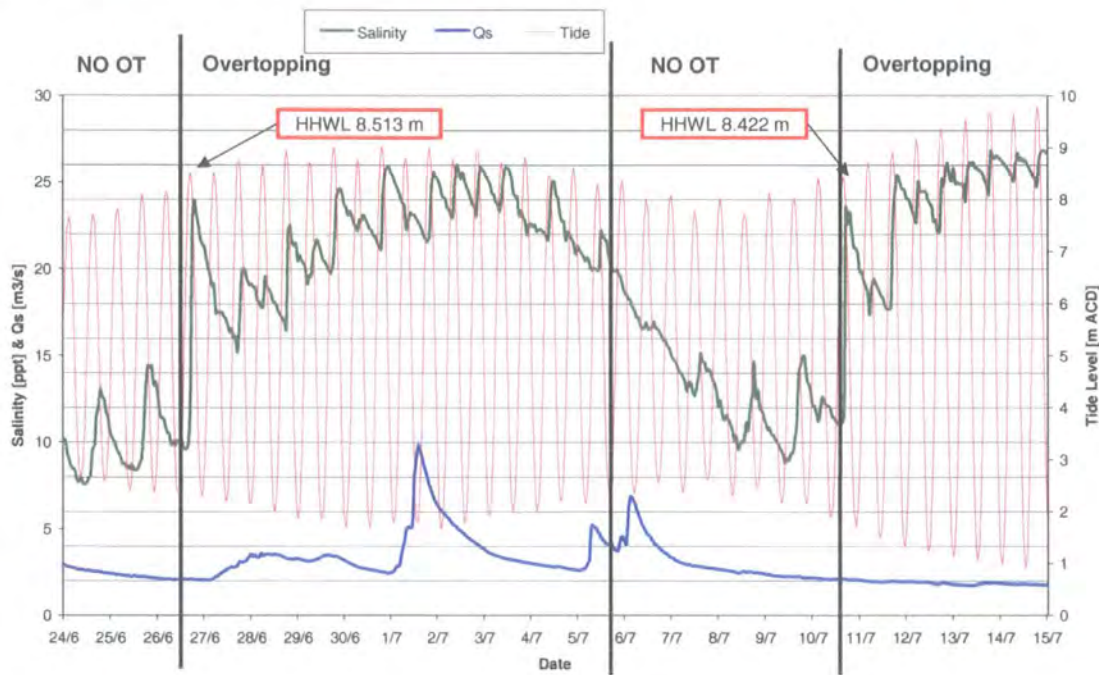
Figure 2-15 Continuous salinity record for Marina Deep during low flows

Continuous water quality monitoring conducted 1999 in the marina area adjacent to the barrage, indicated that seawater ingress is detected at tidal heights  $>8.30$  m ACD (3.30 m

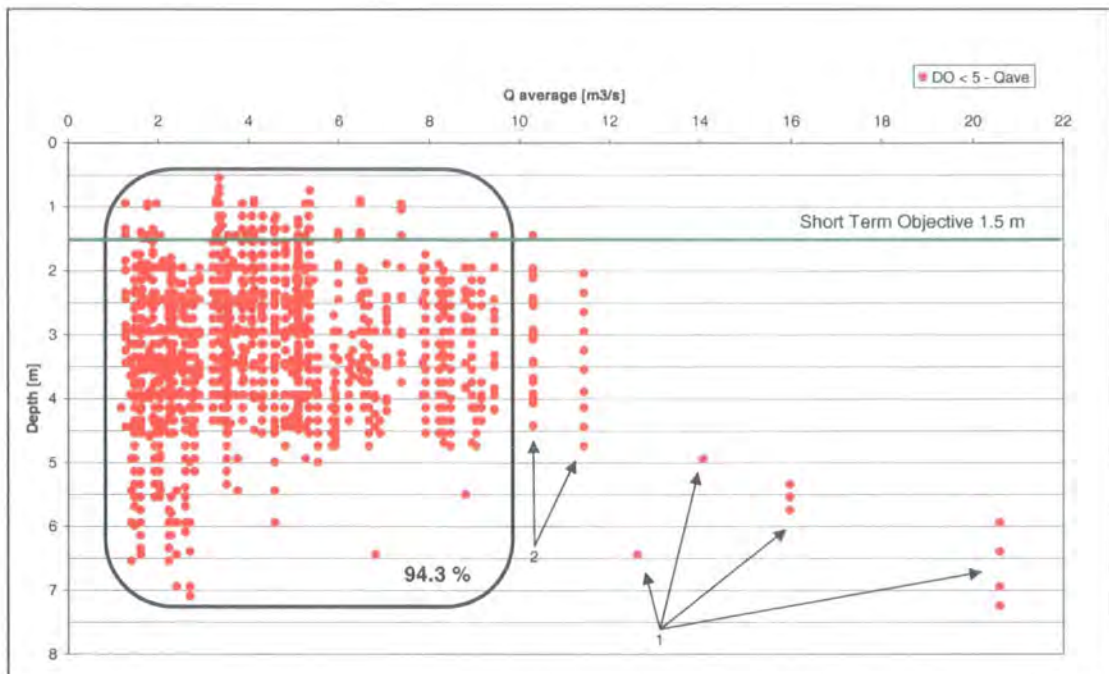
Figure 2-17 DO events (<5 mg/l) vs average flow ( $Q_{ave}$ ) for the pre-aeration period 1994-1998

According to the odds ratios for the external parameters (Table 2-3), freshwater inflow, here given as an average flow over the tidal regime period ( $Q_{ave}$ ), shows a significant correlation with the increase of monitored DO levels below 5 mg/l. (Figure 2-17).

during years 1994-1998, Figure 2-17 shows that, for flow conditions above 11 m<sup>3</sup>/s, no breach was recorded.

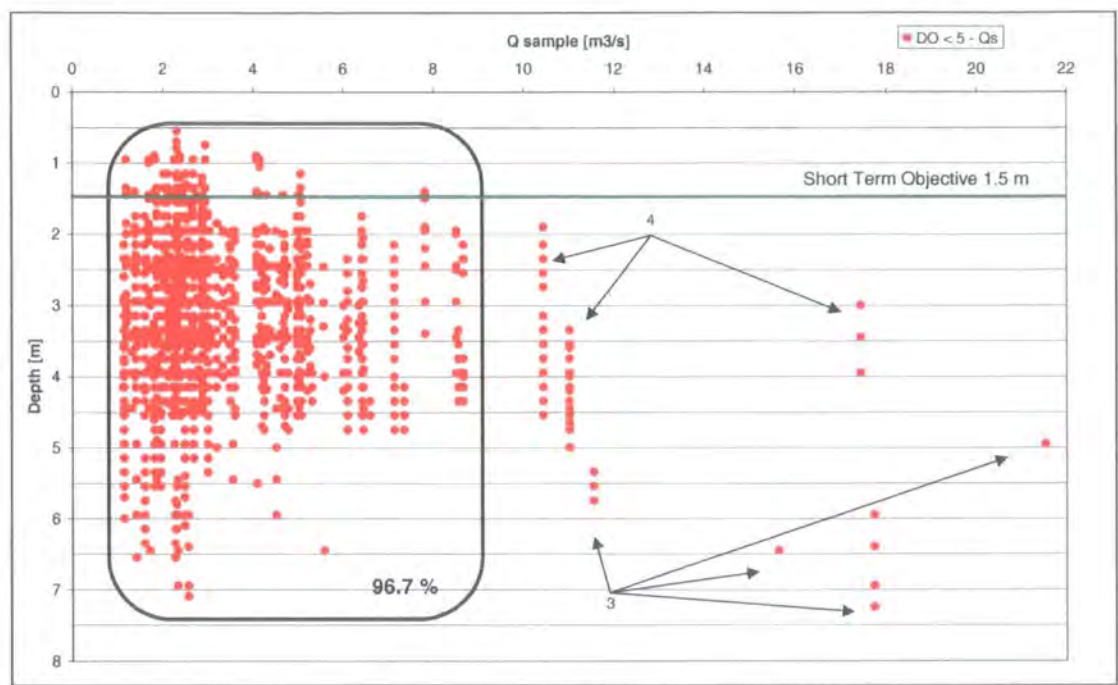
Figure 2-18 DO events (<5mg/l) vs momentary flow ( $Q_s$ ) for pre-aeration period 1994-1998

Some of the years modelled during logistic regression analysis delivered a slightly better fit (1998 - 87.9 %, 1995 – 89.9 %) when the momentary flow measure  $Q_s$  was applied instead of  $Q_{ave}$ . Thus, this plot should also be included here (Figure 2-18).

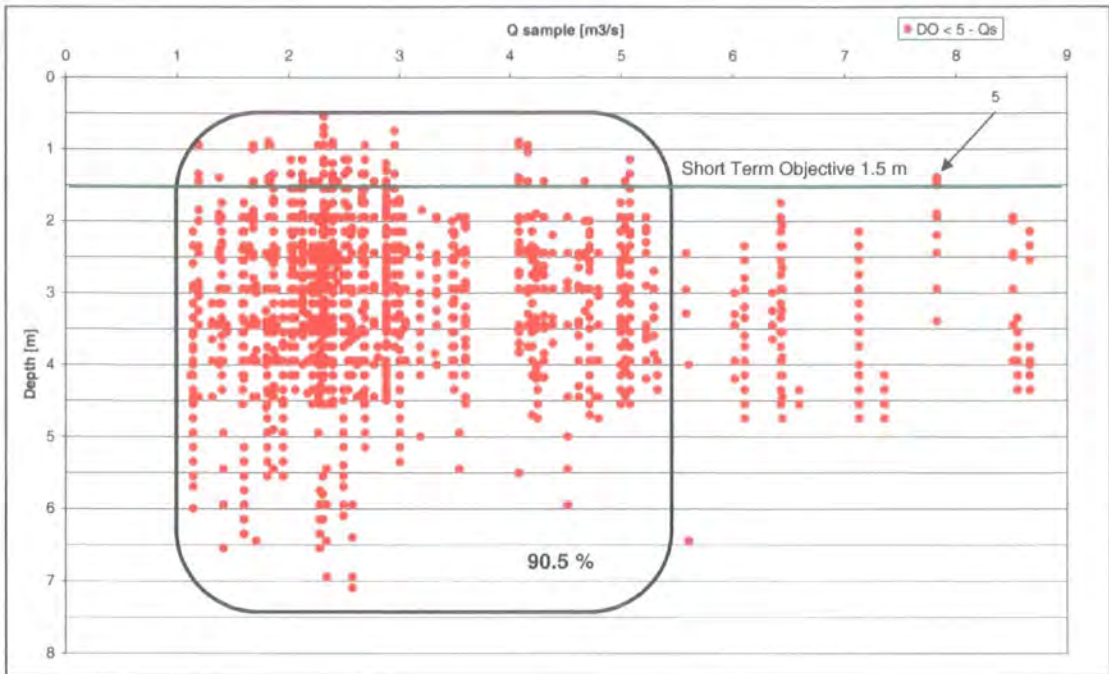
Figure 2-19 DO events (<5 mg/l) vs momentary flow ( $Q_s$ ) < 9  $\text{m}^3/\text{s}$  for pre-aeration period 1994-1998

Focussing further on the established discharge limit of 9 m<sup>3</sup>/s in Figure 2-19, reveals that the majority (90.5%) of DO events can be restricted to freshwater inflows of  $Q_s < 5.5 \text{ m}^3/\text{s}$ .

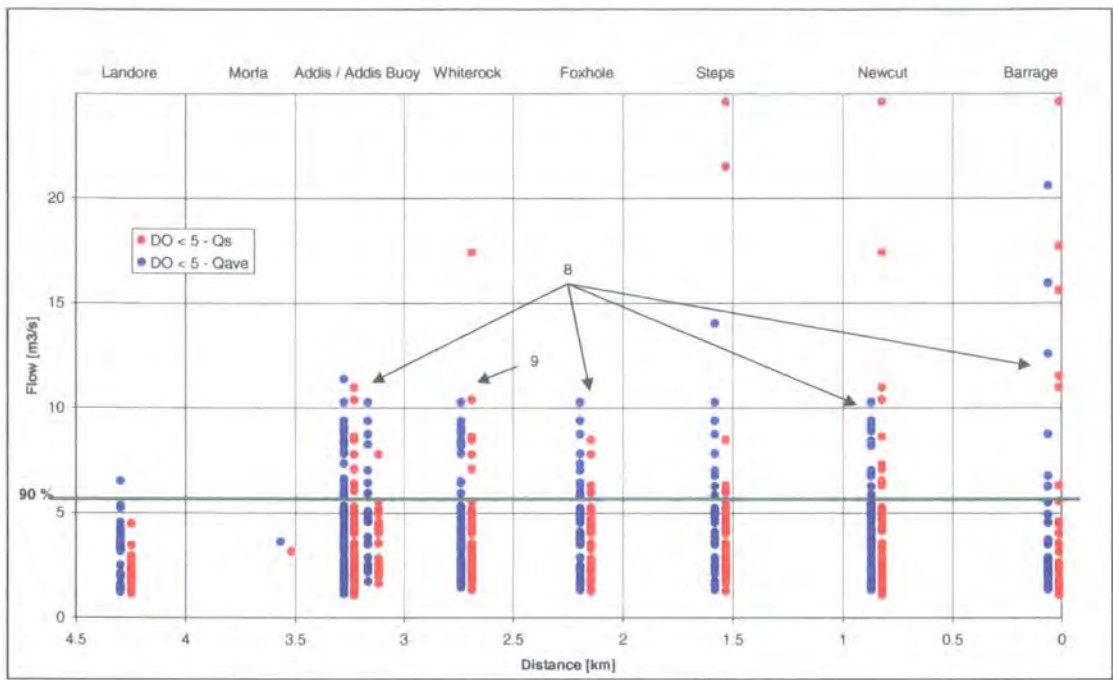
Figure 2-20 Flow vs distance DO events (<5 mg/l) for pre-aeration period 1994-1998

Figure 2-20 displays the distance distribution of DO events in relation to the flow conditions; a slight offset (0.05 km) was used for the  $Q_{\text{ave}}$  values, to improve distinction from the  $Q_s$  values. It is demonstrated that the previously established cut-off flow of approximately 10  $\text{m}^3/\text{s}$  is still applicable for  $Q_{\text{ave}}$  and  $Q_s$ .

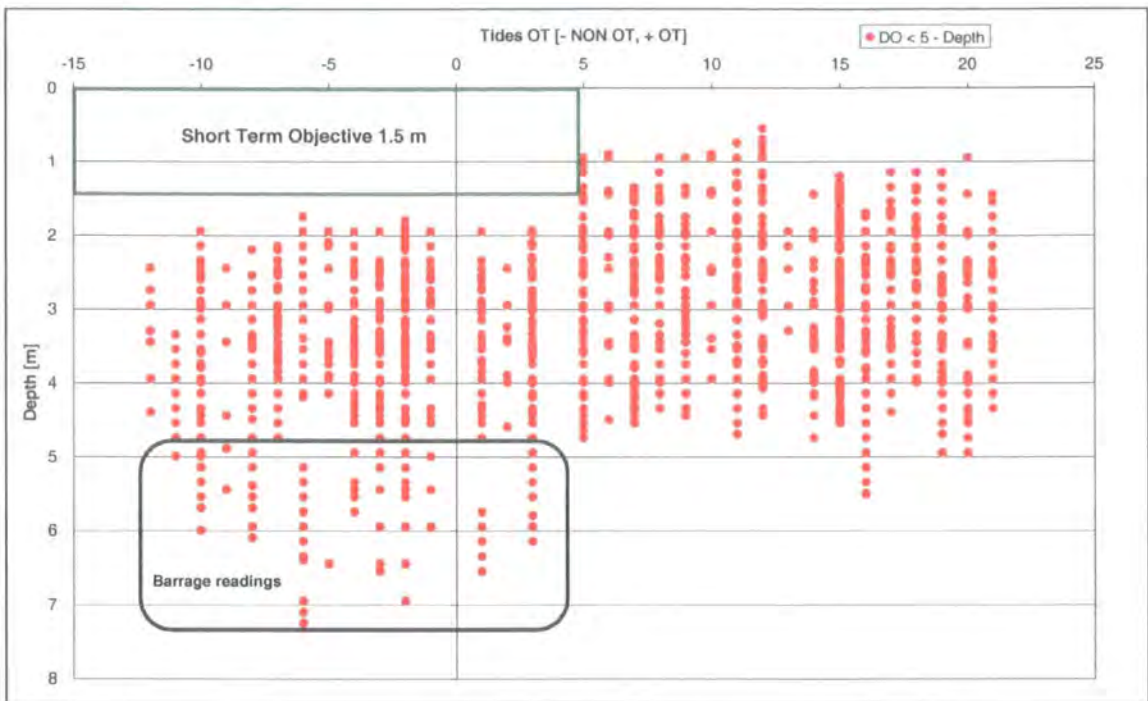
**Figure 2-22 Tidal excursion length (Tides OT) vs depth of DO events (<5 mg/l) for pre-aeration period 1994-1998**

In addition to freshwater flow and tidal height, the tidal excursion period, here defined as Tides OT, was identified as a significant control parameter for increasing the probability of low DO events during numerical analysis (Table 2-3). All recorded events for the years 1994-1998 in relation to amount of tides that had overtopped the barrage at the time of measurement are shown in Figure 2-22.

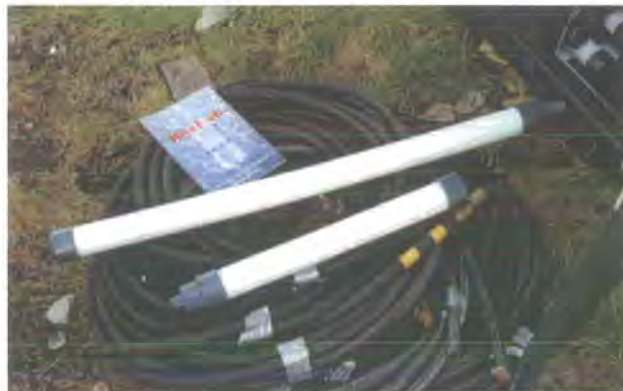
Figure 2-23 Diffuser Tubes & Airlines

With the joint water quality monitoring program of SCC and the EA Wales ongoing, the aeration trials started in August 1998, with 15 diffuser tubes (70 mm OD, 0.5 m length- Figure 2-23) deployed in a 280 m river section between Addis Footbridge and Whiterock Bridge (Figure 2-24). Three sets of five tubes were placed in the deep channel, unequally spaced over distances of 30 m, 50 m and 200 m, respectively. They were supplied by a 16 mm ID self-sinking airline with 3 shore based compressors (Reitsche, 3 phase noise reduced vane type, 1.8 kW) housed in cabinets. In addition, a 'Banana Blade' mixer (ITT Flygt, 1.4 m diameter, app. 36 rpm), housed in a stainless steel frame, was installed adjacent to the fish-pass at a depth of 2 m from the surface. Earlier tests at greater depths indicated that better efficiencies were achieved by lifting rather than pushing the stagnant saltwater over the pass.
